VORTEX PROBLEM AT INTAKE
LOWER ST. ANTHONY FALLS LOCK AND DAM
MISSISSIPPI RIVER, MINNEAPOLIS, MINNESOTA

Hydraulic Model Investigation

May 1979 Final Report

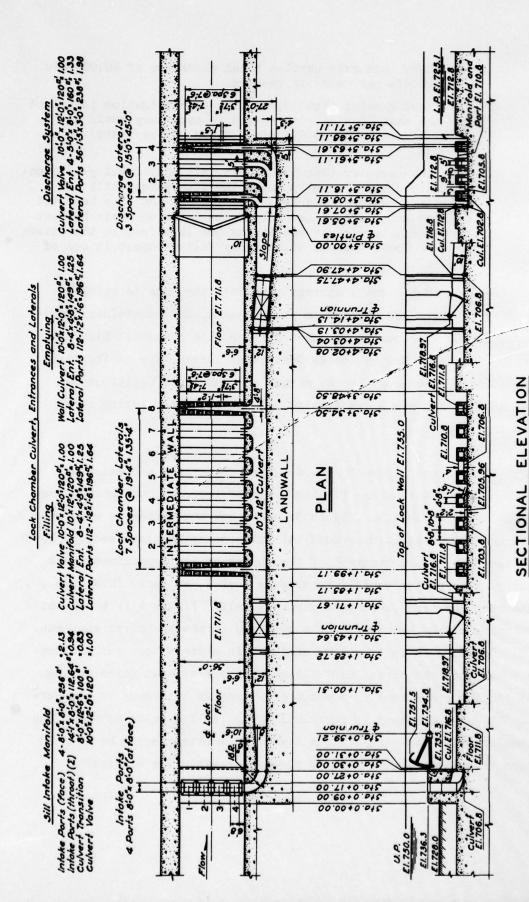
Figure 2. Lower lock filling and emptying system

- 7. Plate 2 and Figure 2 show details of the lock and existing intake manifold. During the filling cycle of the lock, an intense vortex forms over the intake. Figure 3a shows how the vortex is generated from strong flow separation around the bullnose of the intermediate lock wall; Figure 3b is a photograph of the vortex at its approximate peak intensity. The vortex usually forms over port 1, as shown in Figure 3b, but has been observed over other ports as well. Figure 4 is a schematic presentation of the existing intake geometry in the prototype approach.

- 8. On 10 March 1974, a lock employee in a small boat was accidentally drawn into the vortex and killed. The vortex that forms during normal filling operations is considered extremely hazardous to pleasure craft. It was found that by restricting the filling valve movement and lengthening valve time and filling time, the vortices could be reduced to sizes that offer less hazard to pleasure craft. The original

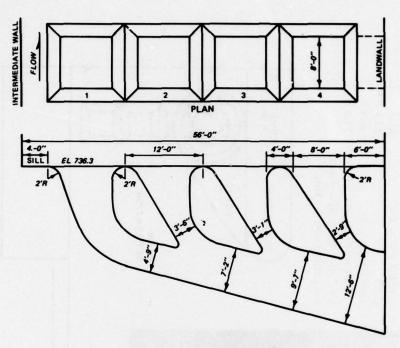
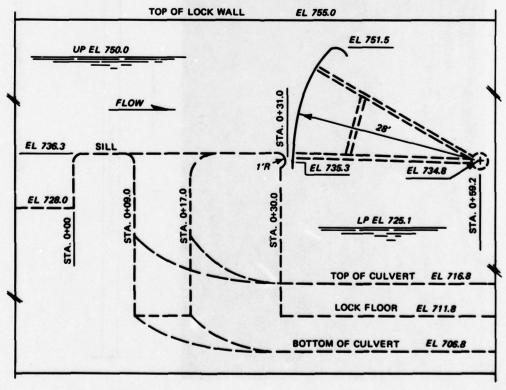
b. Cross section, upstream to downstream, Lower Lock
 Figure 4. Details of existing intakes

a. Cross section, sill intake manifold, Lower Lock

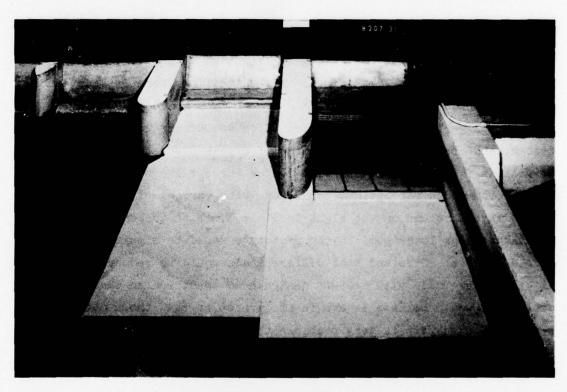
Figure 6. Type 5 (recommended) design of intake, bullnose pier, vortex suppressor, and approach

At no time during these tests did a vortex occur. Swirls and large mild eddies did occur in the model, but there should be no air-entraining vortex problem in the prototype if the type 5 (recommended) design is adopted, constructed, and operated in accordance with the recommended valve time schedules shown above. It should be noted that partial adoption of the design elements cannot be expected to result in optimum conditions in the prototype.

- 31. As a result of very thorough model investigations, a design that eliminated the vortex was developed. The existing intake is in the top of the gate sill with the portals at el 736.3, While the recommended intake portals are in the upstream face of the sill with intake port invert at el 713.8. The shape of the existing bullnose pier at sta 0+54 was changed from round (7.5-ft radius) to elliptical and extended upstream 28.75 ft to sta 0+82.75. With the intakes positioned in the face of the sill to provide deeper submergence and to reduce approach velocities and strong surface and subsurface currents, a certain amount of excavation was necessary below the upstream topography, which was at el 728+ in the immediate approach vicinity. The excavation shown in Plate 18 was the optimum amount required. The vortex suppressor, as detailed in Plate 18, completed the structural and geometry recommendations. Each element is important and collectively the type 5 design will function satisfactorily. In addition, changing from the 2.07-min existing valve time to provisions that will permit valve times of 4.14 and 6.21 min will further improve flow conditions in the lock approach. Whereas the existing 2.07-min valve time fills the lock in about 6.9 min, the 4.14-min valve will fill the lock in 7.9 min and the 6.21-min valve will fill the lock in 8.9 min. These valve times are required

for variations in river discharges. For river discharges from 0 to 7,500 cfs, a 4.14-min valve time is recommended, and for discharges from 7,500 cfs to 40,000 cfs when all navigation ceases, it is recommended that a 6.21-min valve time be adopted. The opening schedule should agree with the opening time ratio in Plate 6.

- 32. Adoption of the type 5 design together with the valve schedules recommended will result in a lock approach free of vortex problems and also in improved navigation conditions in the intake approach area of the lock. Each element of the type 5 design plays an important role in the overall performance, and partial adoption will not result in optimum or safe conditions.

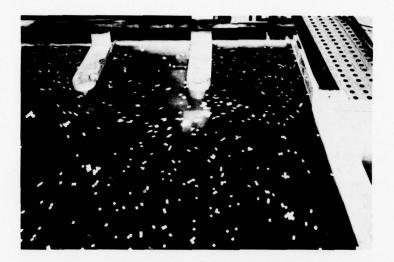
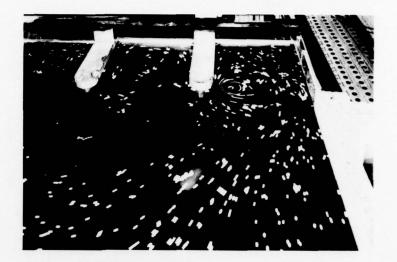
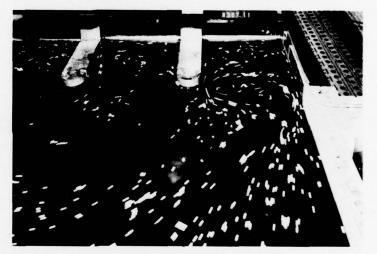
Photo 1. Surface currents during filling operation, type 1 (original) intake, time exposure 5 sec; upper pool el 750.0, lower pool el 725.0, 2.07-min valve time (sheet 1 of 2)

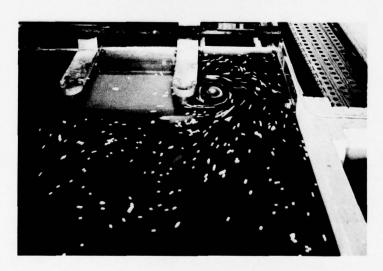
Photo 2. Surface currents during steady-flow peak discharge conditions at type 1 (original) intake, time exposure 5 sec, culvert valve fully open; upper pool el 750.0, lock chamber el 732.0

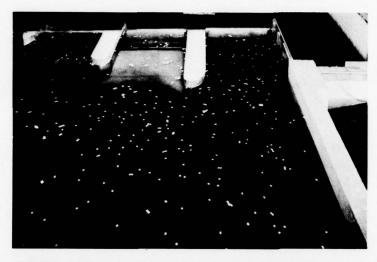
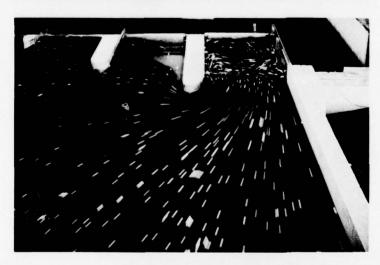
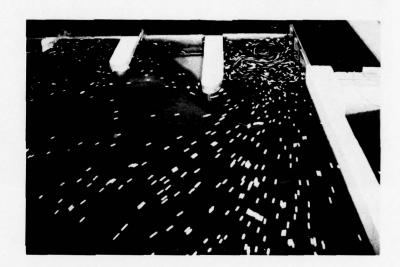
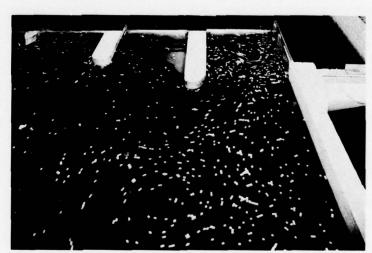
- 20. Surface currents in the immediate vicinity of the type 3 design during a filling operation with no flow through the spillway or auxiliary lock gates are shown in Photo 3. Photo 4 shows flow conditions with a steady-flow (peak) discharge condition. The effect of passing about 15,000-cfs riverflow through spillway gates 1, 2, and 3

Photo 3. Surface currents during filling operation, type 3 design, time exposure 5 sec; upper pool el 750.0, lower pool el 725.0, 2.07-min valve time (sheet 1 of 2)

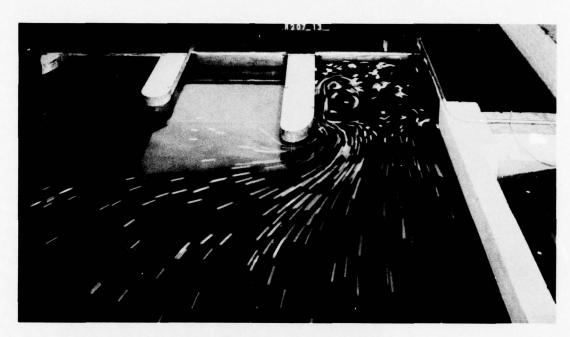
Photo 4. Surface currents during steady-flow peak discharge conditions, type 3 design, time exposure 5 sec; upper pool el 750.0, lock chamber el 732.0, culvert valve fully open

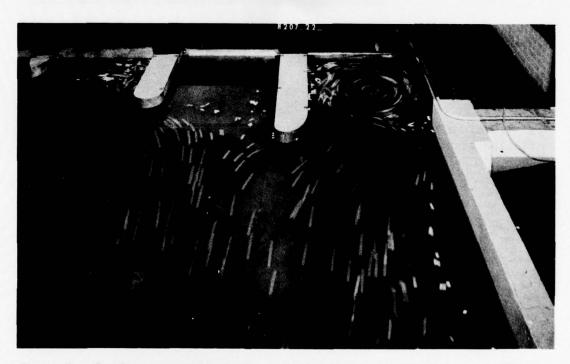
Photo 5. Surface currents during steady-flow peak discharge conditions through intake, type 3 design, culvert valve fully open; upper pool el 750.0, lock chamber el 732.0, auxiliary lock gate closed. Dam gates 1 and 2 open 3 ft, each gate passing 4,920-cfs discharge; dam gate 3 open 3.2 ft, passing 5,230-cfs discharge. Tailgate downstream of dam el 727.0; total discharge through dam approximately 15,070 cfs

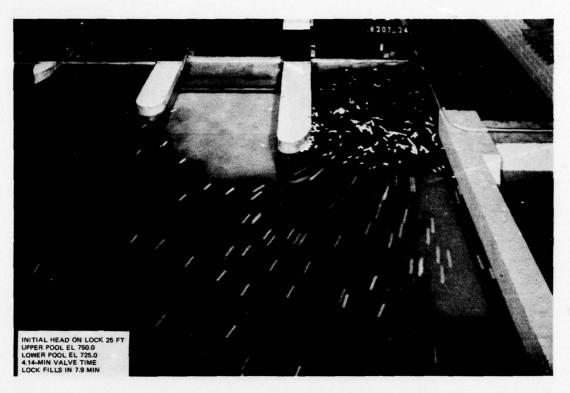
Photo 6. Type 5 (recommended) design, steady-flow peak discharge conditions through intake, time exposure 5 sec, culvert valve fully open; river discharge 0 cfs, discharge exceeded 100 percent of time

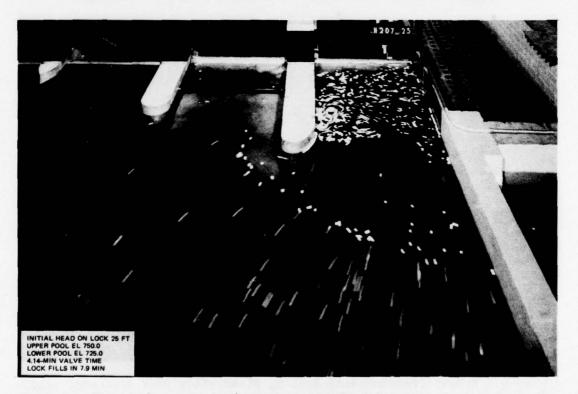
Photo 7. Type 5 (recommended) design, steady-flow peak discharge conditions through intake, time exposure 5 sec, culvert valve fully open; river discharge 2,500 cfs, discharge exceeded 80 percent of time; dam gate 1 opened 1.5 ft, auxiliary lock gate closed

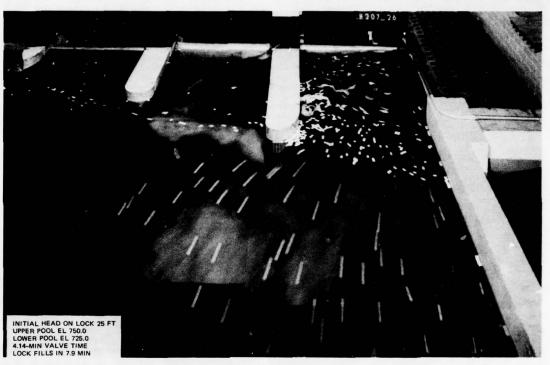
Photo 8. Type 5 (recommended) design, steady-flow peak discharge conditions through intake, time exposure 5 sec, culvert valve fully open; river discharge 5,000 cfs, discharge exceeded 47 percent of time; dam gates 1 and 2 open 1.5 ft, auxiliary lock gate closed

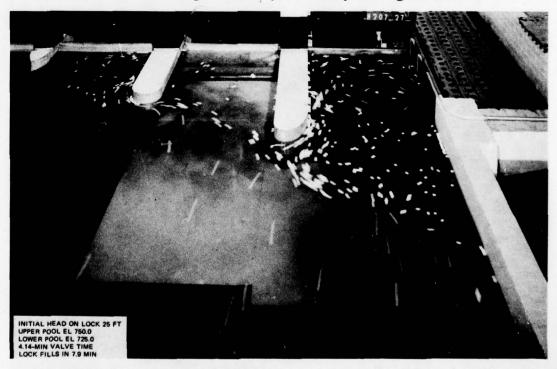
Photo 9. Type 5 (recommended) design, steady-flow peak discharge conditions through intake, time exposure 5 sec, culvert valve fully open; river discharge 7,500 cfs, discharge exceeded 28 percent of time; dam gates 1, 2, and 3 open 1.5 ft, auxiliary lock gate closed
